EBSD and Nanoindentation-Correlated Study of Delamination

Fracture in Al-Li Alloy 2090

W. Tayon^{1*}; R. Crooks²; M. Domack³; J. Wagner³; A. A. Elmustafa¹

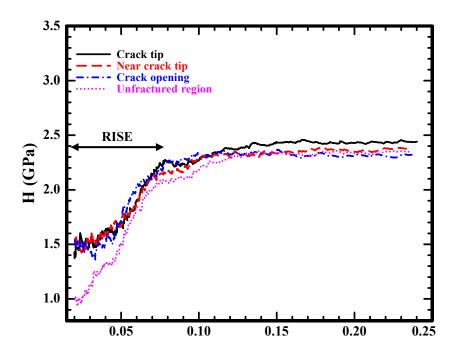
Fig. 4 Typical hardness vs depth plot for a single nanoindent at each region sampled. The range of data exhibiting the reverse indentation size effect (RISE) is noted by the arrow.

Nanoindentation testing was used to evaluate grain-to-grain nanohardness variations in several regions along delamination fractures. Indentation data revealed that this Al-Li alloy exhibited a reverse indentation size effect (RISE). RISE is characterized by an increase in hardness with increasing indentation depth, which is the reverse of the indentation size effect (ISE) observed for other metallic materials in [4]. Fig. 4 illustrates typical hardness versus contact depth (depth of penetration) plots for indents at each region sampled. A single nanohardness value was determined for each indent based on an average of all the hardness data collected within the 100 to 200 nm range of contact depth, where the hardness was stabilized. From these results, average hardness values for grains directly above and below delaminations were calculated.

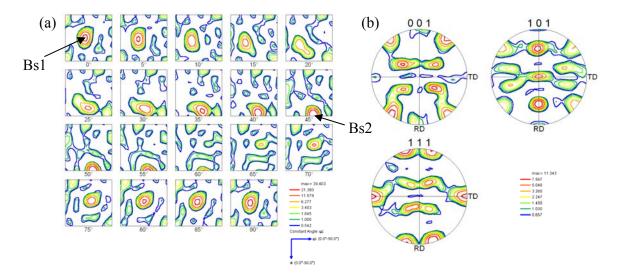
Fig. 5 Texture results for 2090-T81 plate for the region from t/2 to t/4. a) ODF showing ideal Brass orientation along β -fiber; b) Pole figures.

Delamination cracks in aluminum-lithium alloys tend to occur along high angle grain boundaries with misorientations greater than 30° [2]. In this study, all delaminations occurred along grain boundaries with misorientations between 50° and 60°. The "Brass" grain orientation is commonly found in Al-Li-Zr alloys and Al-Cu-Zr alloys (e.g. Supral), and is prevalent in 2090 [2, 5-8]. The pole figures and ODFs in Fig. 5 show a well defined Brass texture. Face-centered cubic crystals have 24 equivalent orientations which can be obtained by rotation about crystal symmetry axes. Texture variants are related by 180° rotations about the orthotropic sample symmetry axes (RD, ND, TD) and share the same form of Miller indices. When these rotation axes do not coincide with the crystal symmetry axes, the variants are not crystallographically equivalent. Brass has two variants, equivalent to 180° rotation about the non-symmetric rolling direction axis, <2-1 1>. In this study, Bs1 is defined by the Euler angles (35, 45, 0) or Miller indices (011)[2-1 1] and Bs2 is defined by the Euler angles (55, 90, 45) or the Miller indices (110)[1-1 2].

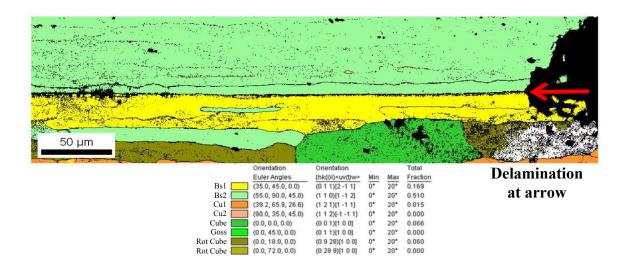
Fig. 6 Typical texture components identified adjacent to delaminations. The delamination in this image is noted by the arrow.

Grain boundaries are typically characterized by misorientation, expressed as angle/axis pairs. Coincident site lattice (CSL) nomenclature, denoted as Σn (where n is the inverse of the fraction of lattice points common to both lattices), is used to categorize grain misorientations as low index (low Σ number) or high index (high Σ number). Ideal Brass variants show a low index misorientation, equivalent to a $\Sigma 3$ (60°/<111>). The coherent twin misorientation in fcc polycrystalline materials is $\Sigma 3$, with a {111} twin plane. All points on the {111} plane are common to both lattices. Since the grain boundary plane for the Brass grains in this study is close to {011}, the Bs1/Bs2 boundary is an "incoherent" twin. Incoherent boundaries are known to be high-energy boundaries; the boundary plane includes lattice sites which are not common to both crystals. A tendency for intergranular fracture along Brass texture variants was observed in the delaminations studied (Fig. 6). The fractured boundaries appeared qualitatively flatter and longer than other boundaries. The grains adjacent to the fracture were on the order of several millimeters in length and 50 to 200 μ m in width with elongation-to-thickness aspect ratios near 10:1, as observed in [6].

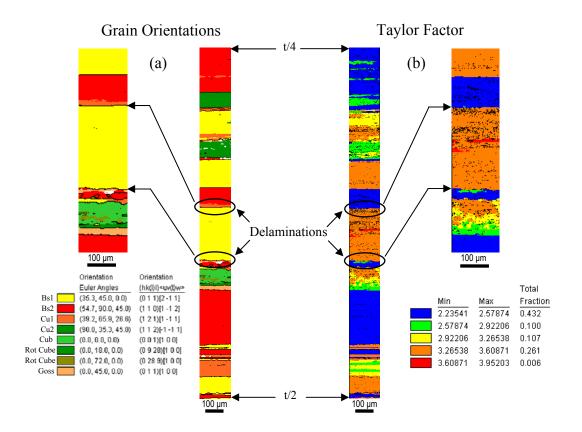
Fig. 7 Grain orientation and Taylor factor distributions for plate thickness from t/4 to t/2.

Delaminations were found to occur at locations shown. a) Distribution indicates predominance of Brass orientations, Bs1 and Bs2 and b) Taylor factor map indicating high and lowest TF associated with Brass orientations.

In the through-thickness scans (beyond the delamination crack tips), numerous layers of Brass oriented grains were present within the sample as indicated in Fig. 7a. The EBSD software was used to color-code grain orientations to the nearest deformation texture component (within 20° of their respective ideal orientations), using the 12 most common (β-fiber) components and variants. Approximately 70% of the material from t/4 to t/2 was characterized as Bs1 or Bs2 grains; similar results were reported for Al-6Cu-0.4Zr [5, 6]. Two of the delaminations on the sample corresponded to locations within this large scanned area, as noted in Fig. 7a within the circled regions and marked by

arrows to the higher magnification view. Roughly 30% of the Bs1 grain boundaries in this region were bordered by a Bs2 grain. Therefore, the occurrence of twin-related Brass-variant grain boundaries was seen to be a common from t/4 to t/2, similar to results noted in [5].

When the TFs were computed for delaminating regions with the simultaneous consideration of normal stress and out-of-plane shear stress, σ_{zz} and τ_{yz} , there was a large disparity noticed between twin-related variants on either side of a fracture. The TFs for grains within the through-thickness scan from t/4 to t/2 are shown in Fig. 7b alongside grain orientations for the same region. The location of two delaminations noted previously within this region have been circled and noted with arrows. The location of the delaminations coincided with Bs1/Bs2 grain pairs which exhibited the largest difference in TF. Typically, one Brass variant had a lower TF around 2.6, while the other Brass variant on the opposing side of the fracture was typically near 3.5. These results show a correlation between delamination fracture

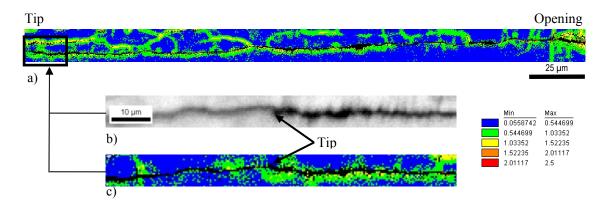
Fig. 8 KAM concentrations in grains bordering a delamination. (a) KAM distribution from opening to tip of a typical delamination, (b) Image quality map corresponding to the enlarged region highlighted in (a) near the tip region, and (c) KAM distribution for the same enlarged region.

Kernel average misorientation (KAM) shows local lattice distortion and may indicate stored-strain energy, localized deformation, and high dislocation density within a given region. Fig. 8 shows KAM for a typical delamination from the opening to tip regions with a magnified section shown of the tip. Sub-grain boundaries that fall within the pre-set misorientation limit of 3° appear as KAM and are particularly found in the grain above the fracture for the delamination

shown. These sub-grain boundaries should be disregarded since they share no relationship with the localized deformation analyzed by KAM. At the opening regions of delaminations, both sides contained significant KAM that was nearly equal in density and magnitude as seen in Fig. 8. Strong deformation in these regions was presumed to result from being within the plastic zone associated with the larger primary crack passing near the opening regions.

At regions further down the delamination, appreciable levels of KAM can be found on one side of the delamination boundary, but not the other. These long bands of KAM appear within approximately 5 µm of the fractured boundary. The KAM concentration appears to diminish near the tip of the delamination. The location of delamination tip was identified with an SEM and has been shown in Fig. 8, image (b). The much thinner, black line ahead of the tip represents the continuation of grain boundary which has not fractured. The higher levels of KAM on one side of the boundary are consistent with a lack of slip accommodation across the delaminating interface.

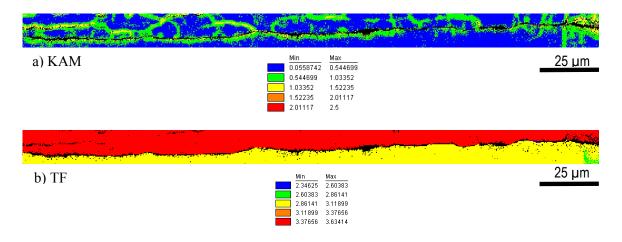
Fig. 9 Correlation between KAM and TF for a typical delamination. (a) KAM distribution along delamination and (b) TF distribution for grains bordering the delamination.

A correlation was noted between the occurrence of KAM in grains bordering a delamination and TF, as illustrated in Fig. 9. Concentrations of KAM were observed along only one side of a delaminating interface. The grain exhibiting the narrow band of KAM was consistently the lower TF grain in the pair. Similar concentrations of KAM along low TF grain boundaries were observed in [10], where it was found that low TF grains sometimes behave as soft grains in the presence of high TF grains. The KAM and TF distributions observed in the current study support the hypothesis that a lack of slip accommodation across the interface, resulting in an excess of deformation damage on the (crystallographically) "softer" side, contributing to delamination fracture.
